MARINE SAFETY ALERT

Safety Alert 3-15

LIQUEFIED PETROLEUM GAS (LPG) Cargo and Hydrate Handling Risks

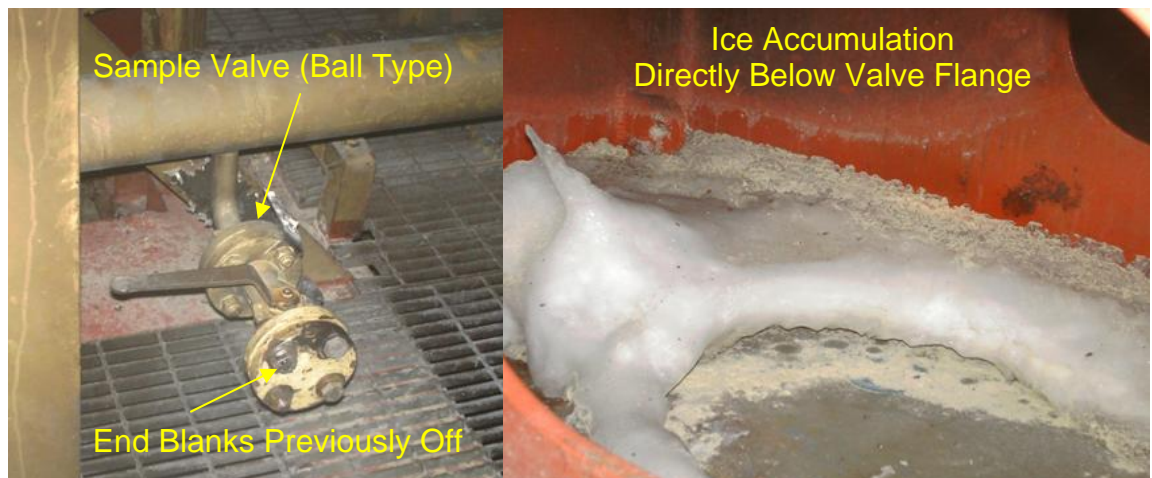
Crewmembers reported that a ball valve at a sample point in a condenser outlet piping was opened on occasion to drain the hydrates into a modified bucket. It was also learned that flanges on the outlet piping of the ball valve had

been removed and left off. Investigators were told that the Cargo Engineer regularly made rounds to manually drain the hydrates to the bucket in order to prevent the freezing of the expansion valve. However, no buckets were found and significant accumulations of ice were noted in the bilge areas below the same sample point for two of the three liquid line drains.

Whether or not buckets were used to capture the hydrates, along with escaping liquid propane, and then later allowed to boil off as stated by the crew, or if the drains were left cracked on or just leaking, as they were found, may never be exactly determined. However, the ice formation in the bilge seems to indicate the latter was the more prevalent condition. Regardless of either initial condition, a hazardous flammable atmosphere developed. With the doors of the compressor room clearly labeled to be kept closed, but latched open, it is likely that proper air flow and volumetric air changes in the space did not occur. It is speculated by crewmembers that a fallen flange blank may have provided the initial spark that ignited the gas. A fire subsequently developed and destroyed electrical cabling and gaskets associated with the condenser. It was extinguished quickly by a crewmember who was in the space at the time, using handheld dry chemical extinguishers.

- Shipboard Safety Management Systems and Operational Manuals be inclusive of all procedures to be expected and performed onboard. In the incident under investigation a procedure for removal of hydrates was unavailable;

- Methods to inspect and identify leaks throughout the cargo system, and corrective actions to take when leaks are identified;
 - Ways to manage and minimize the negative effects of hydrates throughout the entire cargo system;
